[Docket No. FAA-2006-25097; Directorate Identifier 2005-SW-19-AD; Amendment 39-14762; AD 2006-19-05]

Airworthiness Directives; Arrow Falcon Exporters, Inc. (Previously Utah State University); Firefly Aviation Helicopter Services (Previously Erickson Air-Crane Co.); California Department of Forestry; Garlick Helicopters, Inc.; Global Helicopter Technology, Inc.; Hagglund Helicopters, LLC (Previously Western International Aviation, Inc.); International Helicopters, Inc.; Precision Helicopters, LLC; Robinson Air Crane, Inc.; San Joaquin Helicopters (Previously Hawkins and Powers Aviation, Inc.) S.M.&T. Aircraft (Previously U.S. Helicopters, Inc., UNC Helicopter, Inc., Southern Aero Corporation, and Wilco Aviation); Smith Helicopters; Southern Helicopter, Inc.; Southwest Florida Aviation International, Inc. (Previously Jamie R. Hill and Southwest Florida Aviation); Tamarack Helicopters, Inc. (Previously Ranger Helicopter Services, Inc.); U.S. Helicopter, Inc. (Previously UNC Helicopter, Inc.); West Coast Fabrication; and Williams Helicopter Corporation (Previously Scott Paper Co.) Model HH-1K, TH-1F, TH-1L, UH-1A, UH-1B, UH-1E, UH-1F, UH-1H, UH-1L, and UH-1P Helicopters; and Southwest

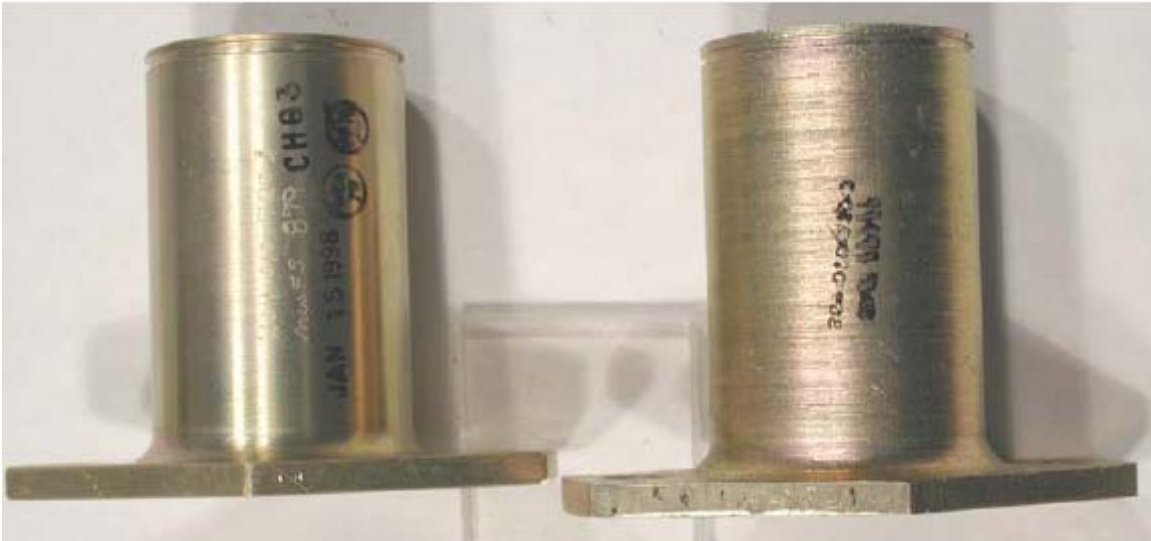
Note 1: T/R sliders manufactured by Forest Scientific, Inc., were produced under a military contract and do not meet the OEM specifications. The machining process resulted in excess surface roughness. See Figure 1 of this AD.

Tail rotor sliders manufactured by Bell Helicopter Textron, Inc. (left) and Forest Scientific, Inc. (right). Note the rough finish of the Forest Scientific, Inc.-manufactured T/R slider compared to the one shown on the left.

(iii) On or before accumulating 1000 hours TIS or on or before 12 months, whichever occurs first, replace each T/R slider that has an illegible CAGE code or Code 15716 or 26098 with an FAA approved airworthy slider without a CAGE code or with a legible CAGE code other than 15716 or 26098. Any T/R slider removed from service based on the requirements of this paragraph is not eligible for installation on any helicopter.
